Solar panel failure detection by infrared UAS digital photogrammetry: a case study

Article in *International Journal of Renewable Energy Research* · September 2020

Solar panel failure detection by infrared UAS digital photogrammetry: a case study.

Leonardo Cardinale-Villalobos *‡, Renato Rimolo-Donadio **, Carlos Meza**

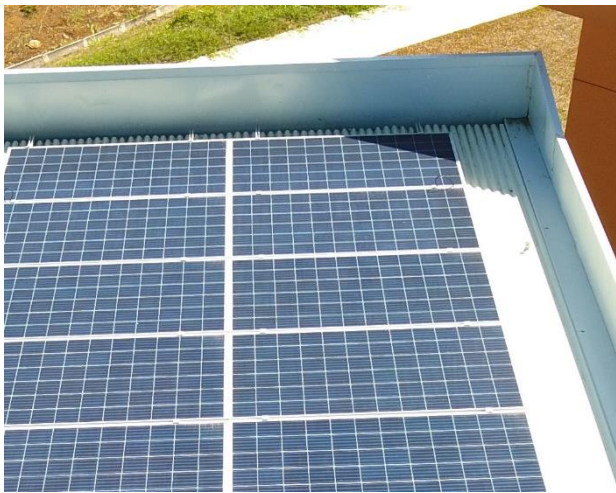
Fig. 1. Example of a solar panel with a partial shadow.

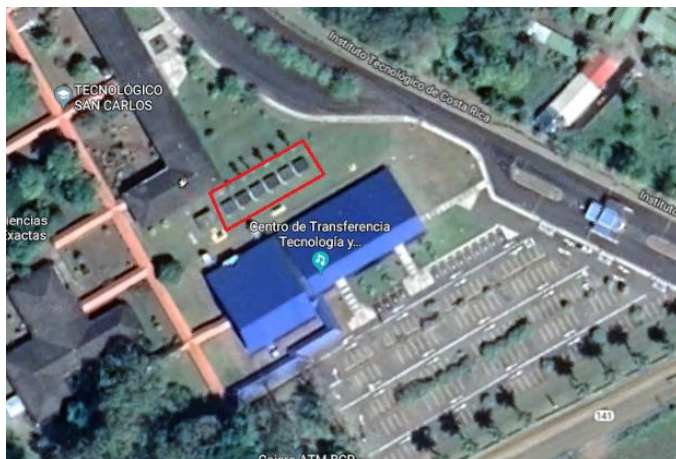
Fig. 5. Aerial photograph of TEC's photovoltaic station (identified in red) located in San Carlos. Source: Google Maps.

The Tecnológico de Costa Rica (TEC) has in its campuses in Costa Rica PV installations with about 1,200 panels that are managed by the Laboratory of Electronic Systems for Sustainability (SESLAB); the energy generated is distributed to different facilities in the campuses [33]. For this article, the 19.4 kW PV station located in Santa Clara, San Carlos, was taken as the evaluation site (see Fig. 5), which has the following characteristics:

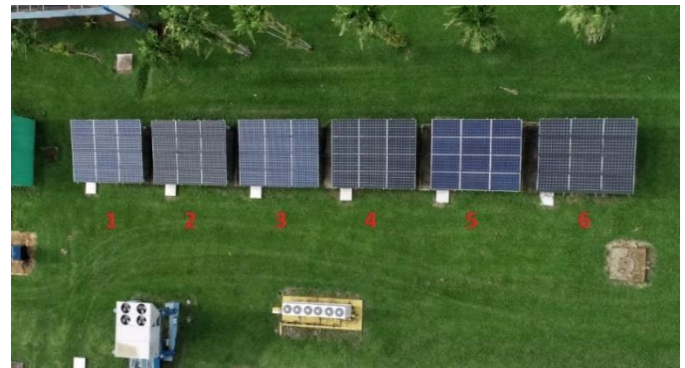
1) Configuration: 72 panels distributed in 6 strings of 12 panels in series (see Fig. 6), with 3 monocrystalline and 3 polycrystalline strings.

2) Dimensions: The panels are 1650 mm x 992 mm and the strings are 4.95 m x 3.97 m.

Fig. 6. Aerial photograph of the photovoltaic installation, where each string is identified.

An RGB picture taken with the drone is shown in Fig. 6.

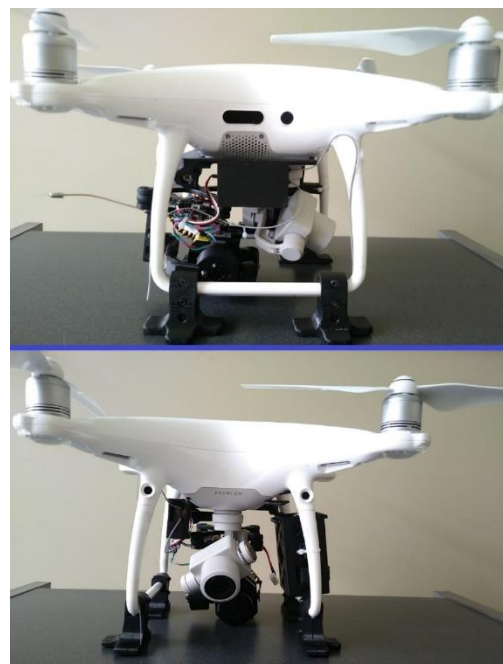
A commercial Phantom 4 Pro multirotor drone was the UAS platform, with a thermal camera attached. According to the manufacturer, the drone (see Fig. 7) weighs 1388 g and a flight time of 30 minutes without the thermographic system.

Fig. 7. Drone with RGB and thermal camera used in this work.

To use the thermal camera with the drone, the following components were included: voltage regulator, 7" monitor (to view the camera image wirelessly), LIPO 3S battery, remote control for the thermal camera gimbal, and the FLIR VUE PRO R camera.

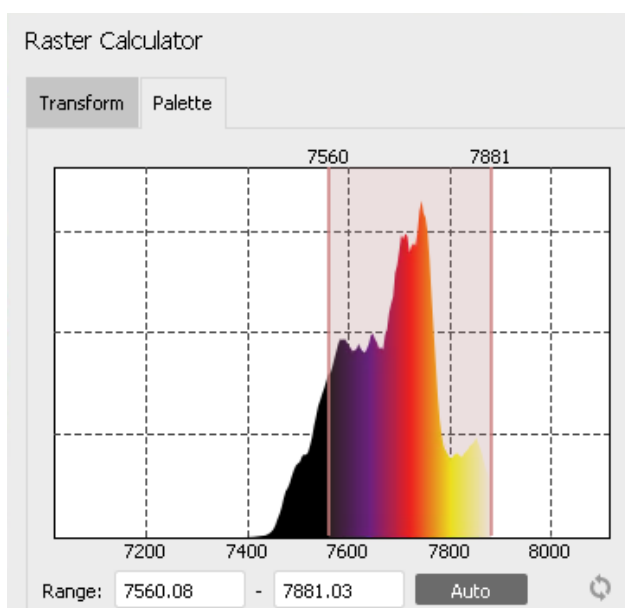
Fig. 11. Color palette assigned for raster processing. Source: image adapted from Agisoft Metashape.

The data processing was done with Agisoft Metashape v1.5.5. Not required photos were manually removed, processing 525 images. A raster transformation was made (see Fig. 11 for the selected palette) and the processes shown in Table 3 were applied. The photogrammetric process allowed the generation of the orthomosaic in Fig. 12.

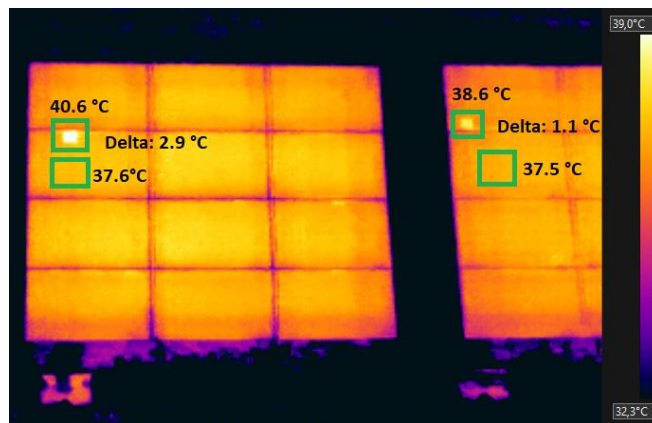
The results of the individual images are in conformity with those of the orthomosaic since it was also qualitatively identified that strings 5 and 6 have a warmer cell (Fig. 14); the quantitative analysis shows that the cells with higher temperature have a variation of less than 3 °C from those with normal temperature, which is within the expected normal operation range. It was also possible to identify the higher heating of the entire string 2 with respect to the 3 (Fig. 15).

Fig. 14. Thermal image of strings 5 and 6 (from left to right). Two cells are displayed with a higher temperature which after a quantitative analysis indicates a temperature differential of 2.9 °C (left) and 1.1 °C (right).

a) In strings 5 and 6, measurements were taken with a thermocouple on the back of the hot cell (the cell with the highest temperature in the thermogram) and of another cell with normal temperature. The results are shown in Table 4.

Table 4 shows that the thermocouple measurement in the hot cells of strings 5 and 6 have a temperature difference of up to 7 °C, in contrast to the thermography where the difference was less than 3 °C (Fig. 14). This is to be expected because the irradiance was higher during thermocouple measurements, which generates more heating in the panels [24]. The results are satisfactory, as they agree with the diagnosis that there is no failure until a difference of 10 °C is present, as mentioned in Section 2.1.

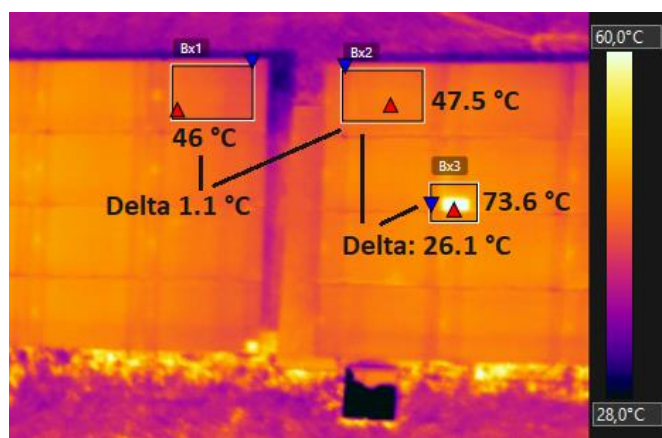
b) An additional thermogram was taken on string 2 (Fig. 16) after correcting the fault detected in the main switch. In this new experiment, a new hot point was found, for which a thermocouple temperature measurement was made to validate the new thermogram (see Table 5).

Fig. 16. Analysis of the thermograph of string 1 (left) and string 2 (right) after repairing the false contact in the main switch of string 2.

The thermogram of string 2 after correcting the fault in the main switch (Fig. 16) shows a difference of 1.1 °C with respect to a neighbouring string, whereas, with the fault

The cell with the highest temperature identified in string 2 shows, both with the thermograph and with the thermocouple measurement, a difference in temperature higher than 26 °C (see Table 5), which tells that the quantitative information of the thermograph allows to effectively detect a failure at the cell level.
